High-Performance, Light and Moisture Dual-Cure Automotive Conformal Coating

Written by Dr. Aysegul K. Nebioglu
and Christopher Morrissey

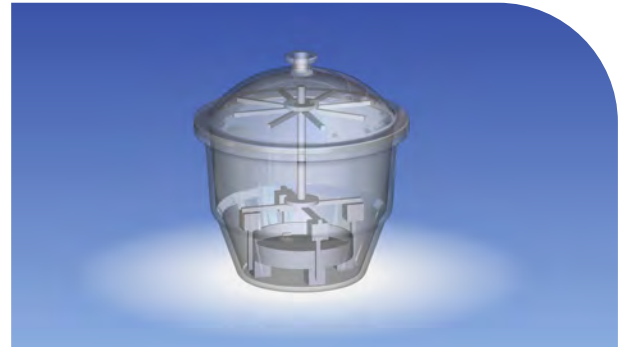
Figure 5. Representation of a flowers of sulfur test chamber

Coated boards were exposed to 5% sodium chloride solution at 35°C for 1500 hours in a salt spray chamber. Flowers of sulfur corrosion resistance was tested using ASTM B809 whereby coated boards were suspended over powdered sulfur in a vented container shown in Figure 5 at around 90% relative humidity and 50°C temperature for 1300 hours.
